HISTORIC PROPERTY INVENTORY FORM

Field Site No. 3506-A **OAHP No.** **Date Recorded** 21 Oct 1994
Site Name Historic Telephone Exchange Building **Revised** 29 May 1998
Common Powerhouse Mechanical Maintenance Shop
Field Recorder K.A. Simmons, M.E. Crist, J.K. Keating
Owner's Name U.S. Department of Energy, Richland Operations Office
Address P.O. Box 550
City/State/Zip Code Richland, WA 99352

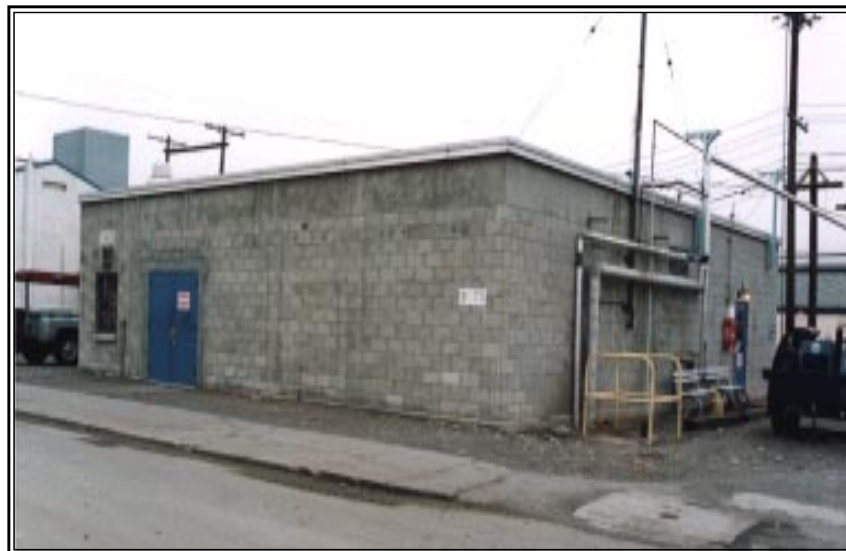
Hanford Photo Lab:
Neg#94010583-3cn
Photography Neg. No. HCRL: Roll 181, frames 7-11
(Roll No. & Frame No.)
View of N, E, & S exterior facades
Date 1994

Photo at right; Neg#94010583-3cn
view of north facade
